University of Connecticut - ENVE 4999

Shoreline Restoration Solutions for Mason's Island, CT

Report by Mia Jordan

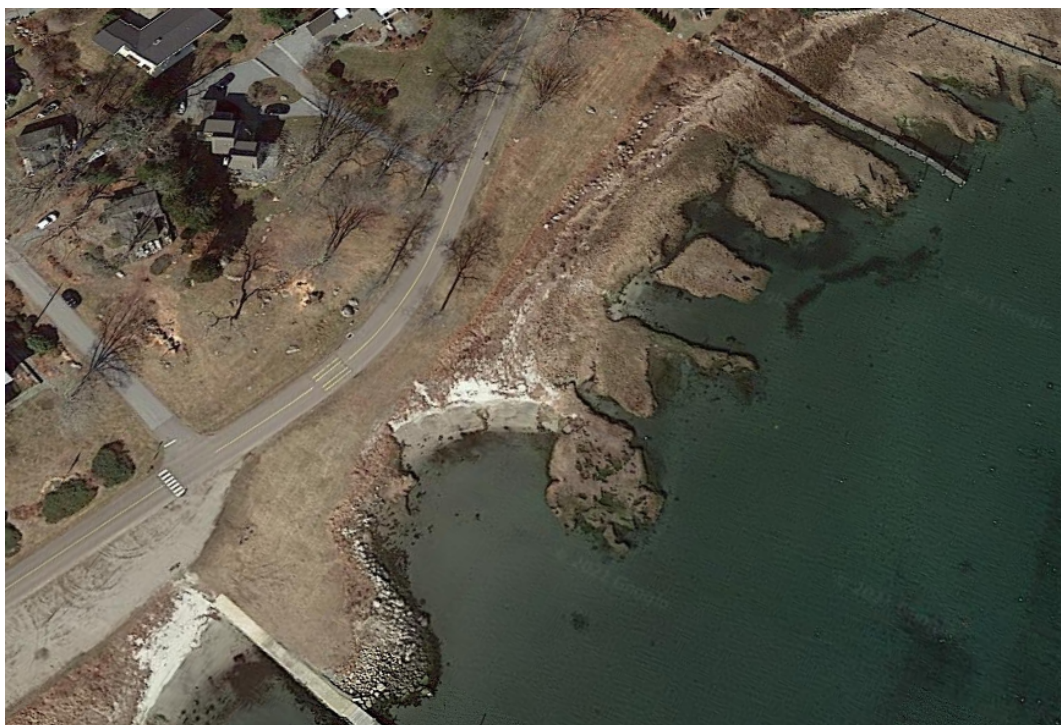
Picture 1: Aerial view of the portion of Chippechaug Trail closest to the eroding marsh.

Currently, a manicured strip of grass lies between the road and the small portion of marsh before the water. The high marsh grasses and lawn are cut down yearly to preserve the residents view of the ocean from their homes. The line where the marsh meets the water is highly uneven and varies greatly, as

shown in the figure below. In some areas the water meets the marsh directly, and in others there is a short strip of sandy beach instead of a marsh between the manicured lawn and the water. In one of these areas a drainage pipe for storm water extends onto the sand.

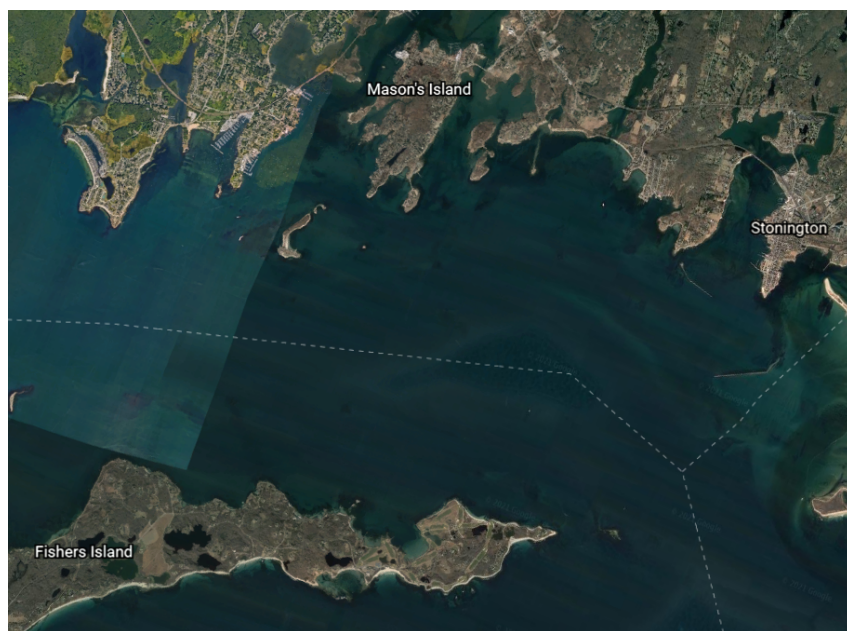
Figure 1: Map of the area surrounding Mason's Island, showing how much of it is sheltered by Fisher's Island.

One important question to consider before researching potential shoreline resilience options is why this shoreline in particular is facing such extreme erosion. Kristin Foster, my main community partner in this project, shared with me in our first meeting that the Island had lost three feet six inches of shoreline between the road and the ocean since just last July alone. This seemed particularly startling to me for several reasons, and raised some questions. First of all, why was the shoreline only eroding so suddenly? Was it previously bad as well, but the residents just did not notice it? Secondly, it made me wonder if any green infrastructure would even be able to mitigate such strong erosion, and if whatever was causing this erosion would erode away any solution as well. In order to begin my research into what was causing this extreme erosion, I first looked at the geography of the area. As seen in figure one below, Fishers Island is directly to the South of Mason's Island. However, there is one portion of open ocean that diagonally reaches the southeast corner of the island, and is not sheltered by Fisher's Island. One important term that will be used for much of this report is fetch, or wave energy that is created by wind moving across the ocean's surface. The more open ocean there is for uninterrupted wind to travel across, the higher the fetch will be, and the larger and more powerful the waves reaching the shore will become. Based on this concept, it seems that fetch plays a role in the erosion the island is facing (14).

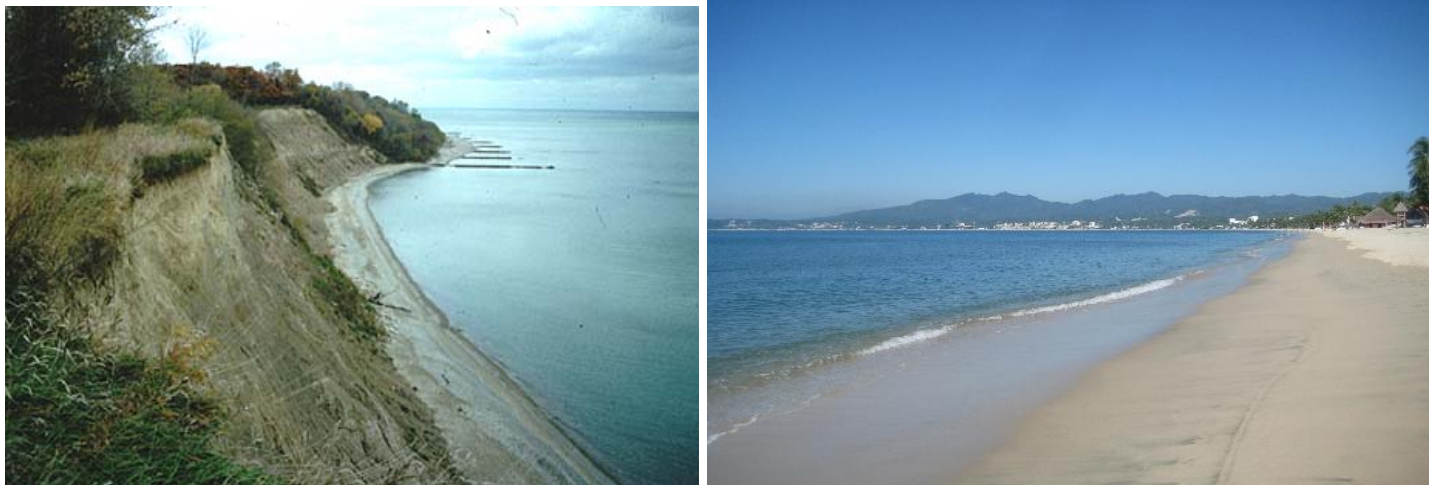
Pictures 2 and 3: Highlighting the visual difference between a highly sloped (left) and flat sloped (right) shoreline.

Another factor that influences erosion is the steepness of a shoreline. Pictures one and two above highlight the two different types of shorelines, and the differences between a steep (left) and gentle (right) one. In shallow water, a wave increases in height due to bottom friction compressing the wave length, and eventually the wave will break once the height of the swell is approximately 80% of the water depth (15). The steeper the shoreline slope, the closer to shore the waves will break, bringing more sediment back out with them. If a wave travels gently up a flat slope the energy will be gradually dispersed, but a steep slope, or even worse no slope at all, means that the wave energy will hit the shoreline with full force at a perpendicular angle (14). In the case of Mason's Island, the shoreline is very steep. Because the area is a marsh, this slope is almost 90 degrees vertical, causing severe undercutting and scour.

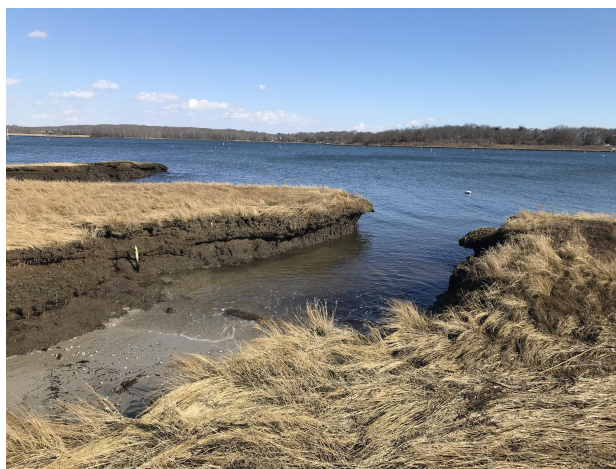
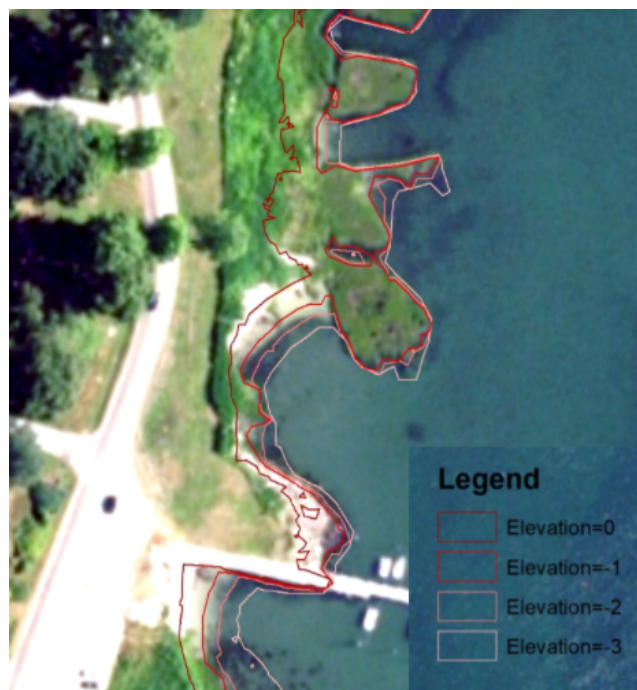
Figure 2 (right): Elevation map for Mason's Island showing the highly sloped shoreline. Figure created by Tao Wu.

Picture 3 (above, left): The eroding marsh of Mason's Island, CT (Picture by Mia Jordan)

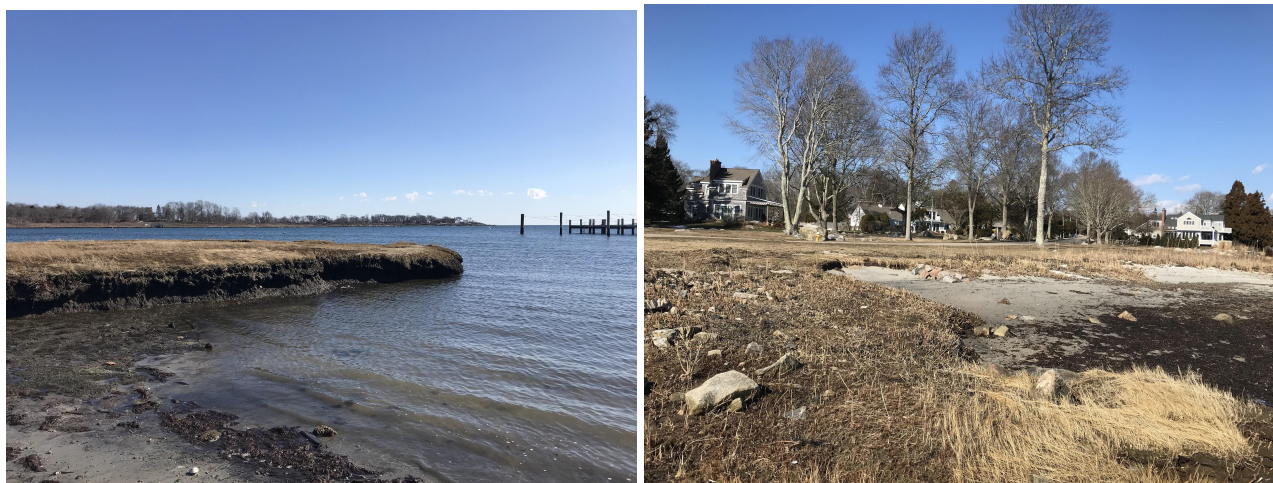
Pictures 4 and 5: The erosion and undercutting of the marsh adjacent to Chippechaug Trail. Note the rocks on the shoreline in picture 5 (right), which were placed by the residents of the island in an attempt to protect the shoreline from storm waves.

One other possible source of the extreme erosion that is suspected, but has not been confirmed, is the underground makeup of the area. Several soil tests were recently conducted in the area of interest that showed the makeup of the soil at least three feet down was entirely sand with no hard rock or root structure. Although these tests were done more inland and not on the marsh itself, they suggest that the entire area might be just as unstructured and easily erodible. Another suggested cause of the erosion is air or water pockets under the marsh itself that may contribute to the marsh collapsing and falling into the ocean when disturbed. Pictures four and five below show the undercutting and erosion of the marsh.

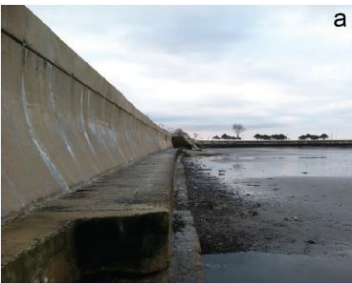
Type of Infrastructure	Best Conditions for Implementation	Diagram	Pros	Cons
Seawalls / Bulkheads	Any

a	Study building materials, instant protection	Protection does not last (erosion under the wall), causes more erosion down the beach, harms ecosystems
Groynes / Jetties	Any

Table 1: Comparison of common shoreline protection devices, noting the conditions best for implementation, a figure of each, and pros and cons of each (1,5,7,11).

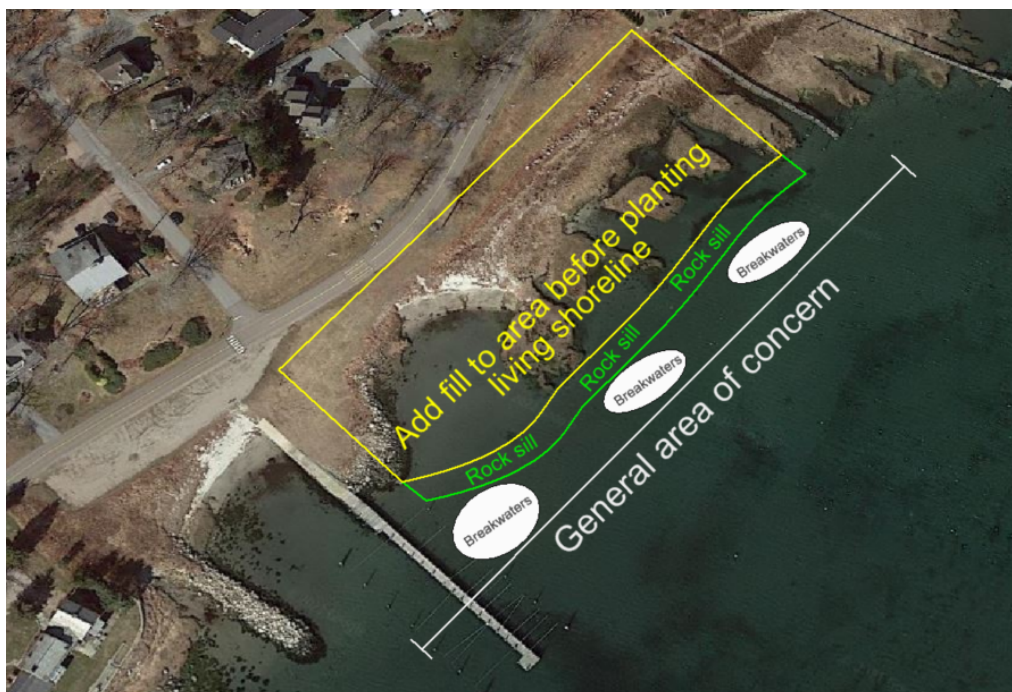
Figure 5: Potential design for a living shoreline and protective devices (Photo taken from Google earth, overlay created using Microstation)

Despite whatever seems to be the best solution for Mason's island just based on the physical conditions alone, another important factor to consider is cost. Though the Mason's Island Shoreline Task Force has been regularly applying for grants and funding opportunities to restore their shoreline, exactly how much money they will be receiving is not yet set in stone. In addition, the actual cost of implementing the shoreline will vary greatly based on the company who installs it, the solution chosen, and where the materials are from. Considering how expensive offshore breakwaters typically are, other options could be coupled with the living shoreline to protect it from the high fetch. Sea walls would not be a good idea due to their destructive nature, however rip rap or rock sills would both be good options. Boulders are much cheaper than specially designed underwater structures, and they could be placed slightly outwards into the water from the living shoreline in order to trap sediment behind and enhance marsh growth up to the rock wall. The following diagram shows what this might look like.

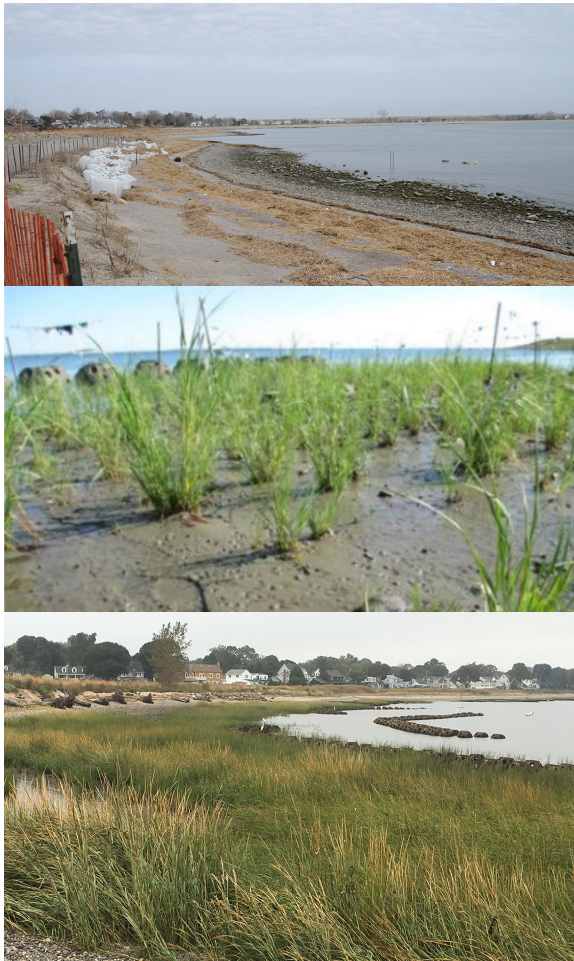
Pictures 6 through 8 (left): Before, middle, and after photos of the Stratford Point living shoreline project in Stratford, CT. Source: www.sacredheart.edu

The two key takeaways from this project are relating to time, and order of construction. First, the Stratford point restoration proves that any living shoreline planted will not be immediately effective, and it will take years to fully grow and fill the area. As pictures six through eight show (left), while the middle point of the project right after planting was better than the before picture, it is still not nearly as full grown as the complete after picture. Secondly, it is important to note the order in which this project was completed. The artificial reef balls were constructed and implemented months before any plants were added to the area, so that their effectiveness could be checked beforehand. Then, once it was confirmed that they were reducing wave energy hitting the shore, the living shoreline could be planted. This similar technique would be largely useful for Mason's Island in order to lessen the chances of a failed living shoreline implementation.
